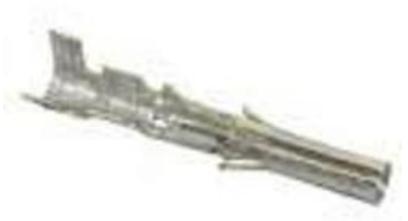
The male side of 6 pin molex probably. (pic 3) shows where the problem is most likely. the molex, although male, the contact connections inside the six holes are female-ish (pix 4,5,6). although the open tips get crimped/compressed the first time the connectors are mated, over time with heat, moisture etc. they expand. Intermittent/flaky symptoms are consistent with this kind of fault.

Attached FAQs on removing the control panel and board, so they can get to the connectors.
