Frequently Asked Questions

NOVA 1624-II Stud nuts loosening

Date Raised: 21 February 2017

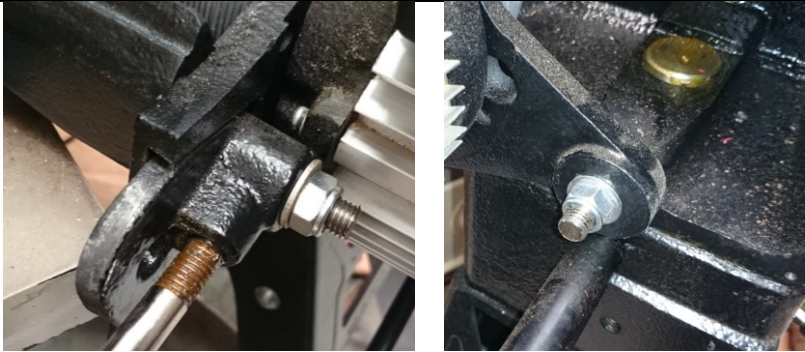
The nuts on the motor mount plate on the NOVA 1624-II lathe may become loose due to vibration of the machine. This issue often occurs due to insecure connection of the studs to the headstock.

Step No.	Description	Image
1.	<p>Remove both nuts shown in the image and wriggle it around with your hand while lifting the motor to see if they are loose.</p> <p>If either stud is loose and not firmly connected to the headstock, it needs to be tightened.</p>

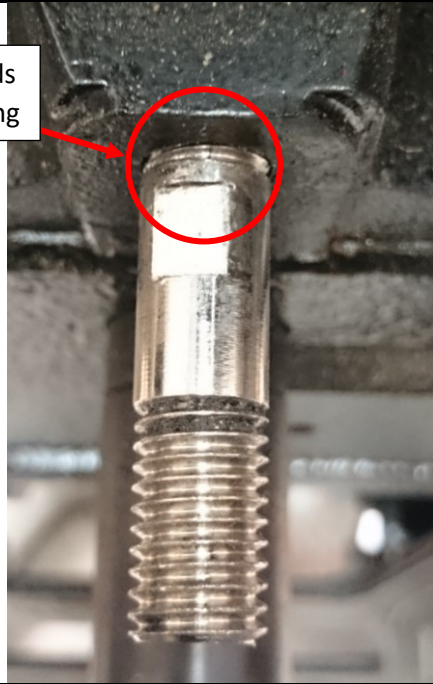
Threads showing

No threads should be showing when the studs are fully tightened.

- 3.** Tighten with the spanner.
Ensure that both studs are fully tightened.

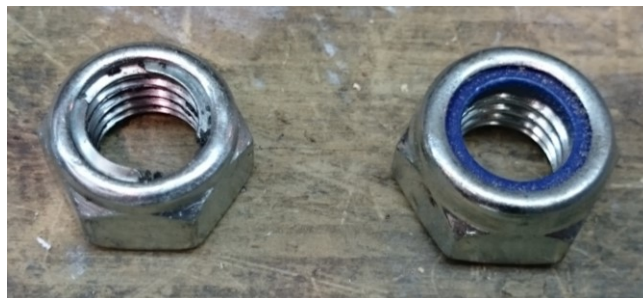
Left: Self-Locking Nuts

Right: Nylon Nuts

If the procedure above does not fully resolve the problem, the nuts on the studs may require replacement. The nuts which comes with the lathe are **M12 nylon nuts** and it can be replaced with **M12 self-locking nuts** for better resistance against vibration.
