Teknatool International Limited

Frequently Asked Questions

DVR XP and 2024 Index Mechanism Loose/ Rattling noise in headstock

Date Raised: 5 April 2017

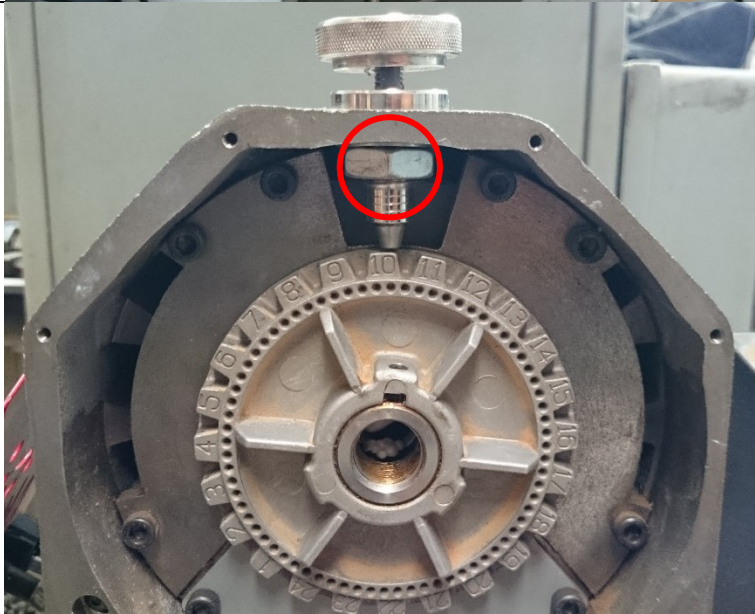
If the indexing mechanism on the DVR XP or DVR 2024 mechanism is feeling loose and rattling around during use, the lock pin and its M16 nut may be missing or loosened.

2.	<p>When the back panel is removed, it will expose the control board and the index wheel.</p> <p>You would find the nut (indicated in image) to be loosened or missing.</p> <p>Note: If the nut is missing it is highly likely that it has gone inside the headstock mechanism. You may need a flash light and a magnetic retriever to recover it.</p> <p>Tighten the nut and secure the index pin into place. This will stop the rattling.</p>

If you find the index mechanism to be broken, please contact our services for replacement.
