Teknatool International Limited

Frequently Asked Questions

RPS Error on NOVA Voyager Drill Press

Date Raised: 24 January 2017

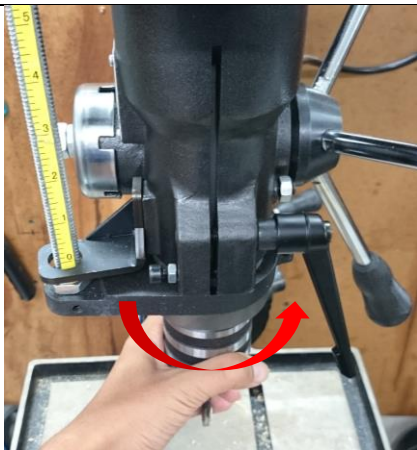
The **Rotation Position State (RPS)** error occurs when the optical sensors which gives position feedback has been obscured, damaged or disconnected. This happens mainly due to the build-up of dust after long time of use, blocking the optical sensors.

Step No.	Description	Image
1.	Spin the spindle by hand and retry the motor. This may create a draught through the sensors.
