Teknatool International Limited

Frequently Asked Questions

How to fix clicking noise and “Low Voltage” message on DVR XP lathe

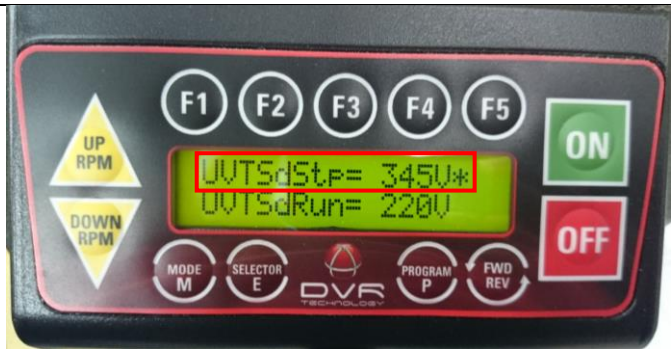
Step No.	Description	Image
1.	Enter service mode on the lathe. To get in and navigate through service mode on the lathe follow the FAQ: How to enter Service Mode and Check serial no. & parameter on DVR XP lathe.	NO IMAGE
2.	Navigate through the menu pages on service mode. Locate the parameter “UVTsdStp=345” Note: Make sure that there is a “*” next to the parameter

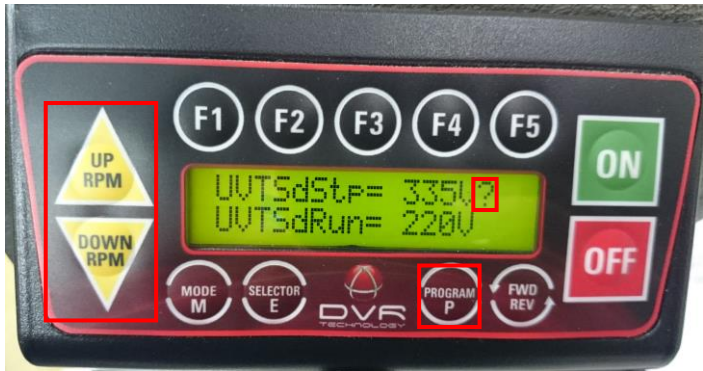
3.	Change the parameter value from 345 to 340 or 335 Press <Selector E> then the “*” will change to a “?” allowing the user to save changes made to the parameter value. Change the parameter value by pressing <UP RPM> or <DOWN RPM> Once the parameter value is changed to 340 or 335 press <Program P> to save the change into the software.

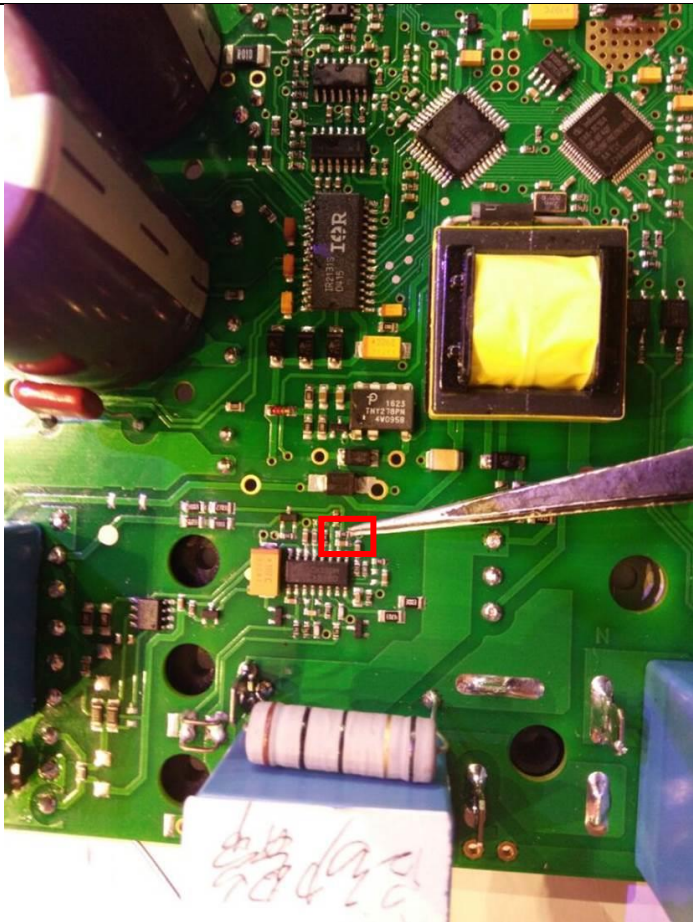
Step No.	Description	Image
1.	<p>Turn off the machine and remove the control board from the headstock.</p> <p>To remove the control board from the headstock, follow the FAQ: How to Change the DVR Control Board</p>	NO IMAGE
2.	<p>Take the coil off from the control board.</p> <p>Change the resistor indicated in the image from a 11K ohm to a 10K ohm resistor by soldering.</p>

This problem is caused by the PFC circuit on the control board having a noise on the feedback loop and lead to PFC shutdown in a very short period therefore DC bus voltage is less than the threshold in the software.
 i.e. Circuit malfunction on the control board
