**Teknatool International Limited**

## Frequently Asked Questions

### DVR 2024 “Low Voltage” issue

Date Raised: 8 February 2017

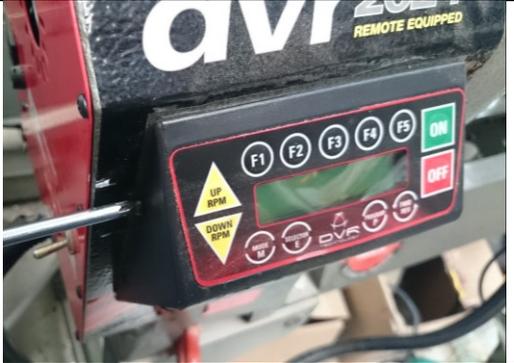
Step No.	Description	Image
1.	Remove the cover of the control panel by removing the screws. This will expose the control circuit board.

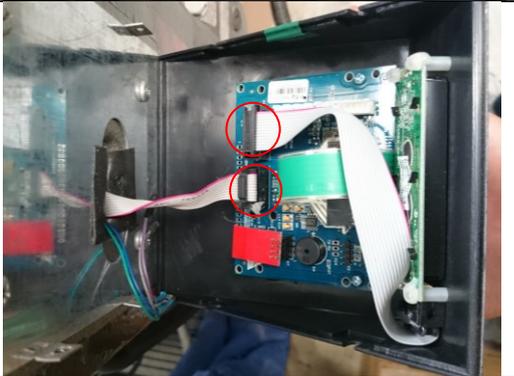
2.	Unplug and re-plug both ends of the grey ribbon cable from the interface board to the key pad panel and from the interface board to the main board.  Retest with power to see if the issue still exists.

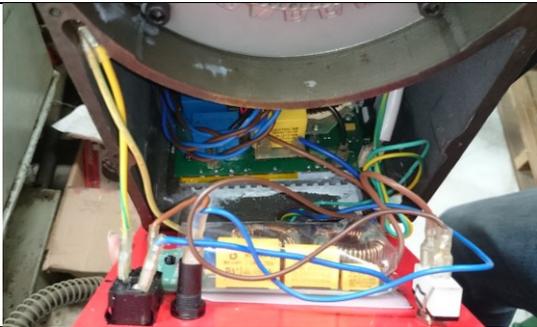
2.	Remove the back panel of the headstock by unscrewing the hex screws using the 2.5mm Allen key  <b>Note:</b> The removal procedure of the main circuit board is shown in the <b>FAQ: How to change the DVR control board.</b>

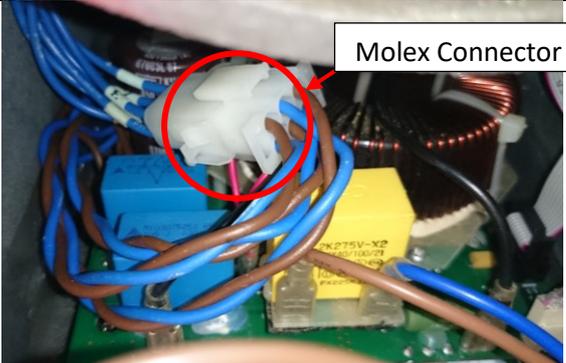
3.	The removal of the control circuit board will allow access to the Molex connectors which may be hidden at the back.

<p style="text-align: center;"> <i>Figure 1: Male Molex</i>                      <i>Figure 2: Female Molex</i> </p>

4.	When you have gained access to the Molex connectors, check to see if there are any defects in each of the connectors. Check for any loose connections on the wire side and if there is any loose connection, re-crimp it with a new conductor crimp.  After re-crimping, assemble everything back together and retry with power.  <b>Note:</b> Follow the instruction/ warnings on how to reassemble the main circuit board since there is a potential of short circuiting which can lead to permanent damage of the circuit.
