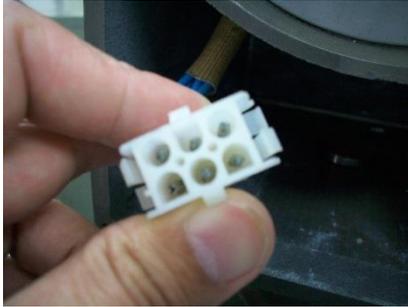
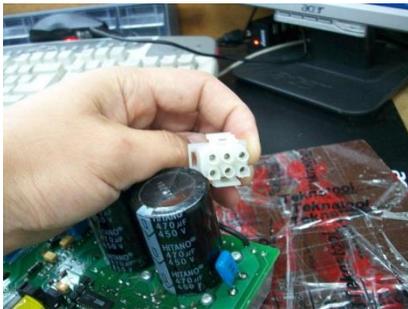
The male side of 6 pin molex probably. (pic 3) shows where the problem is most likely. the molex, although male, the contact connections inside the six holes are female-ish (pix 4,5,6). although the open tips get crimped/compressed the first time the connectors are mated, over time with heat, moisture etc. they expand. Intermittent/flaky symptoms are consistent with this kind of fault.

Attached FAQs on removing the control panel and board, so they can get to the connectors.
